Smoke and Dye Testing Summary

High Level Sewershed

Test ID	Test Type	Date Inspected	Company / Super.	Blower MH	Ground Condition	Notification Made?	Total Length
S1028-270	Smoke	9/2/2009	ADS/TM	S11MM1027MH	Dry	Yes	1,493.72

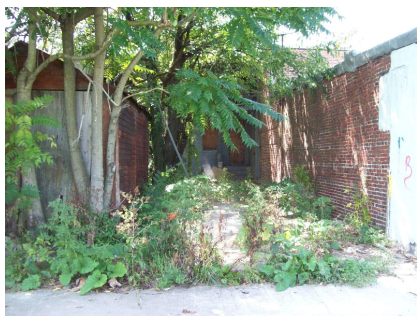
Picture \S1028-270-OB01-P01.jpg

Source Service Lateral

Location Paved concrete

Comments Smoke from service lateral in paved concrete behind house. 4683 Park Heights Ave.

Comments Back of house, 4683 Park Heights Ave.

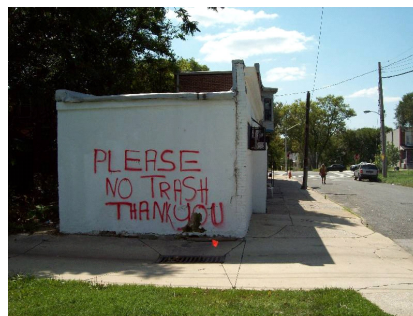
Picture \S1028-270-OB02-P01.jpg

Source Catch Basin

Comments Smoke from catch basin in alley adjacent to 3139 Virginia Ave.

Comments Alley adjacent to 3139 Virginia Ave. looking southwest

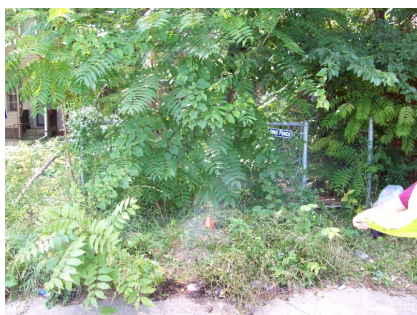
Picture \S1028-270-OB03-P01.jpg

Comments Smoke from service lateral in back yard. 4679 Park Heights Ave.

Comments Back yard, 4679 Park Heights Ave.

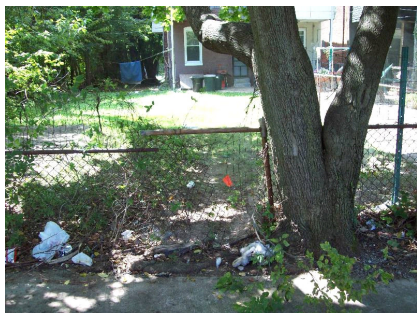
Picture \S1028-270-OB05-P01.jpg

Comments Smoke from service lateral in back yard. 4655 Park Heights Ave.

Comments Back of house, 4655 Park Heights Ave.

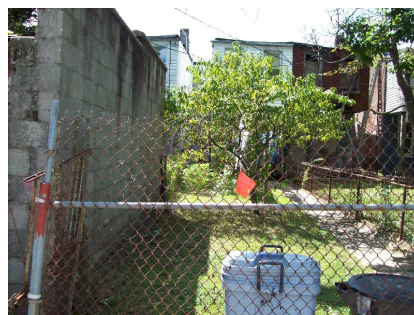
Picture \S1028-270-OB04-P01.jpg

Comments Smoke from cleanout in back yard. 4667 Park Heights Ave.

Comments Back of house, 4667 Park Heights Ave.

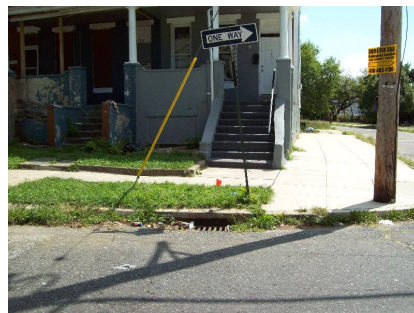
Picture \S1028-270-OB06-P01.jpg

Comments Smoke from catch basin along curb in front of 3135 Virginia Ave.

Comments Front of house, 3135 Virginia Ave.

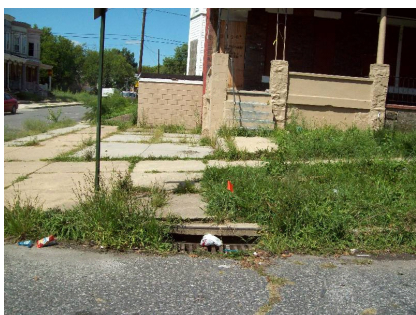
Picture \S1028-270-OB07-P01.jpg

Comments Smoke from catch basin along curb in front of 3130 Virginia Ave.

Comments Front of house, 3130 Virginia Ave.

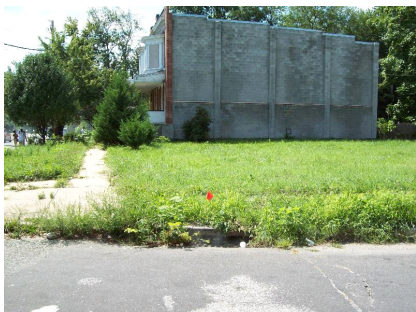
Picture \S1028-270-OB09-P01.jpg

Comments Smoke from catch basin along curb at side of lot. 3132 Virginia Ave.

Comments Side of lot, 3132 Virginia Ave.

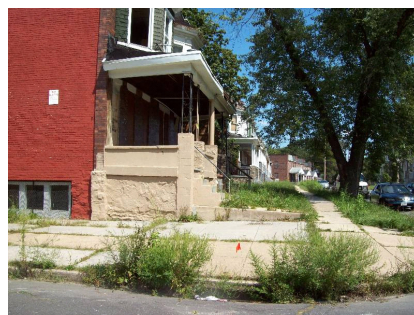
Picture \S1028-270-OB08-P01.jpg

Comments Smoke from catch basin along curb at side of 3130 Virginia Ave.

Comments Side of house, 3130 Virginia Ave.

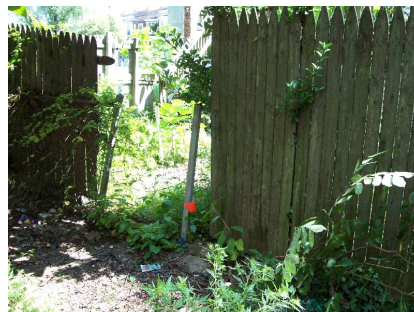
Picture \S1028-270-OB10-P01.jpg

Comments Smoke from service lateral in back yard. 3142 Virginia Ave.

Comments Back of house, 3142 Virginia Ave.

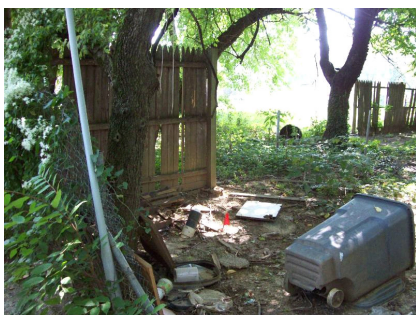
Picture \S1028-270-OB11-P01.jpg

Comments Smoke from service lateral in back yard. 4715 Park Heights Ave.

Comments Back yard, 4715 Park Heights Ave.

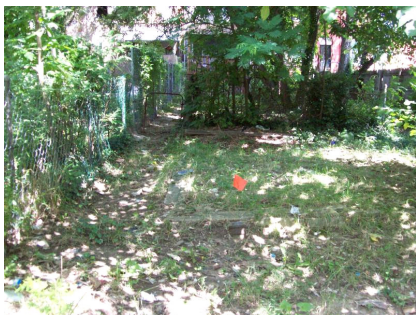
Picture \S1028-270-OB13-P01.jpg

Comments Smoke from cleanout in back yard. 4706 Delaware Ave.

Comments Back of house, 4706 Delaware Ave.

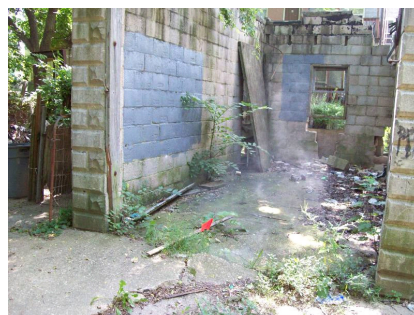
Picture \S1028-270-OB12-P01.jpg

Comments Smoke from service lateral in paved concrete behind house. 4723 Park Heights Ave.

Comments Back of house, 4723 Park Heights Ave.

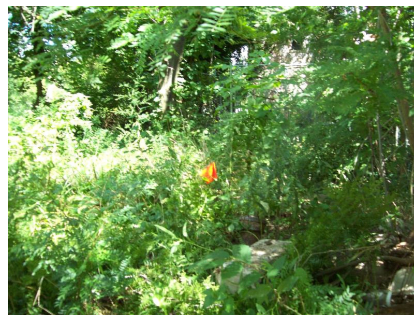
Picture \S1028-270-OB14-P01.jpg

Comments Smoke from cleanout in back yard. 4708 Delaware Ave.

Comments Back yard, 4708 Delaware Ave.

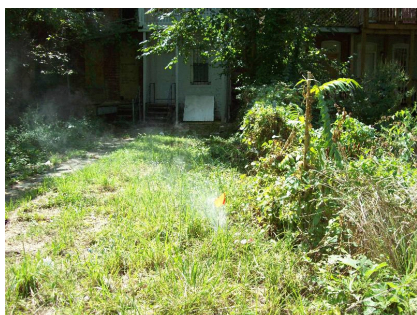
Picture \S1028-270-OB15-P01.jpg

Comments Smoke from cleanout in back yard. 4735 Park Heights Ave.

Comments Back of house, 4735 Park Heights Ave.

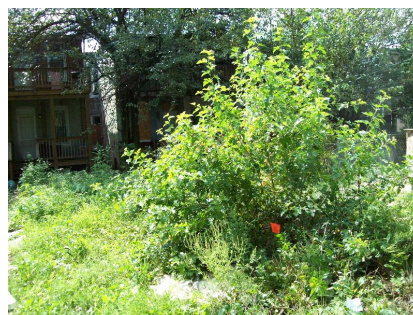
Picture \S1028-270-OB16-P01.jpg

Comments Smoke from service lateral in back yard. 4739 Park Heights Ave.

Comments Back of house, 4739 Park Heights Ave.

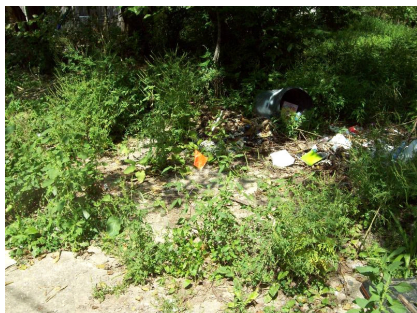
Picture \S1028-270-OB17-P01.jpg

Comments Smoke from cleanout in back yard. 4716 Delaware Ave.

Comments Back yard, 4716 Delaware Ave.
